Mangakotukutuku Stream Tributary Inspection - 29 July 2012

Fitzroy Park

Grant Blackie

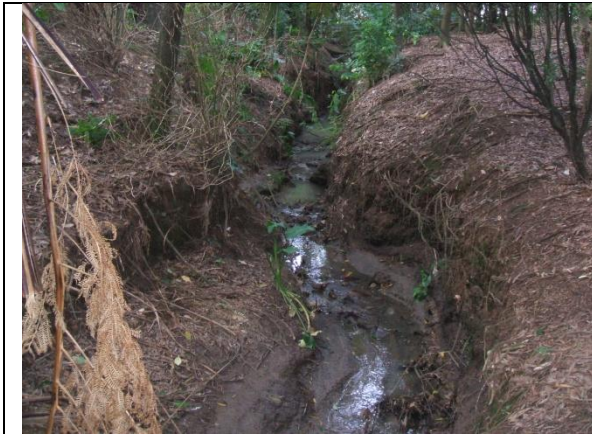
The main channel (photos 1-12) has mainly very sandy banks/soft bed and is severely eroding over much of the reach observed.

There is very little groundcover or bank vegetation present capable of preventing the current bank/bed erosion.

1. Eroding sandy banks

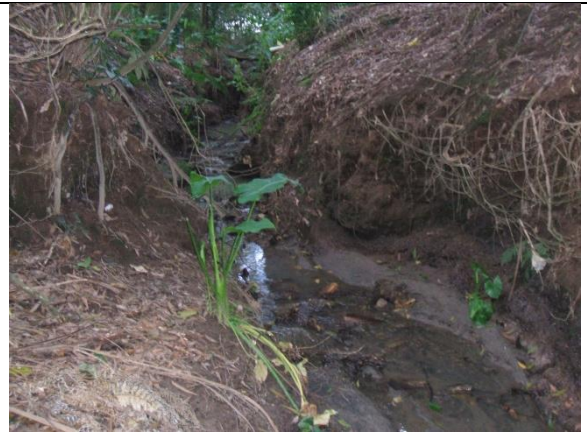
2. Eroding sandy banks

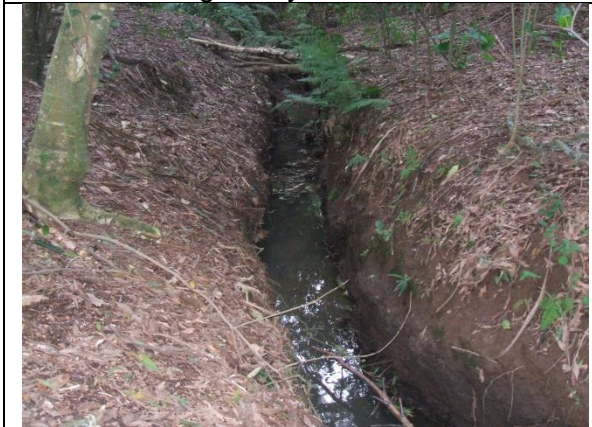
3. Down cutting into a 'slot'

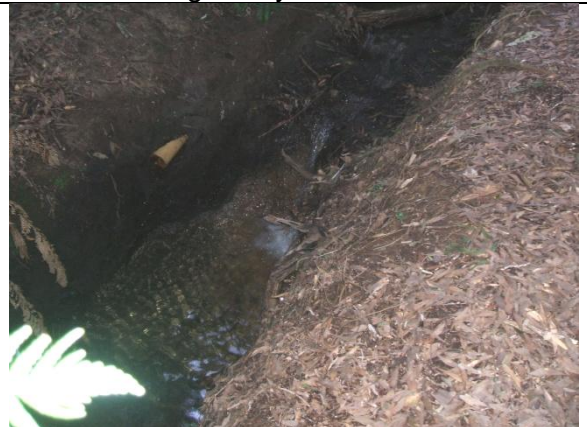
Photo 4 is of an area of headward bed erosion where there is a 1m (approx) drop in the bed as it erodes upstream.

4. 1m drop – headward channel erosion

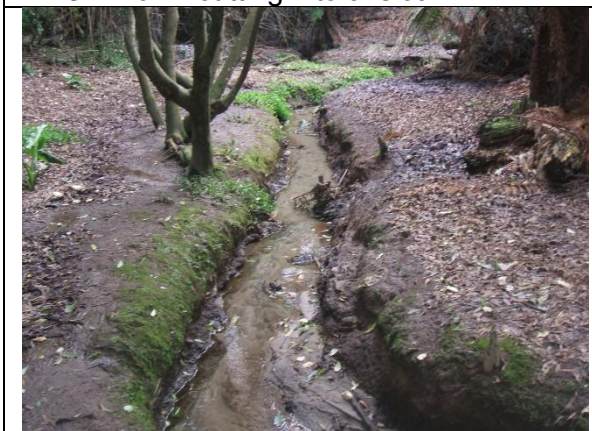
5. Eroding sandy banks

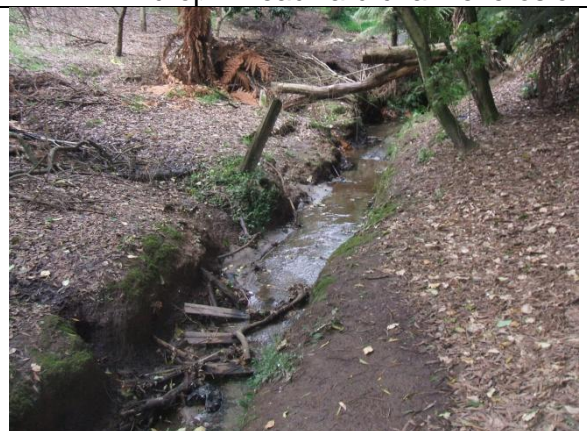
6. Eroding sandy banks

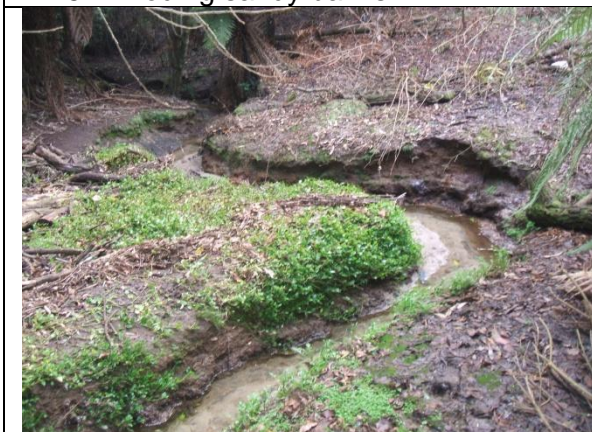
7. Eroding sandy banks

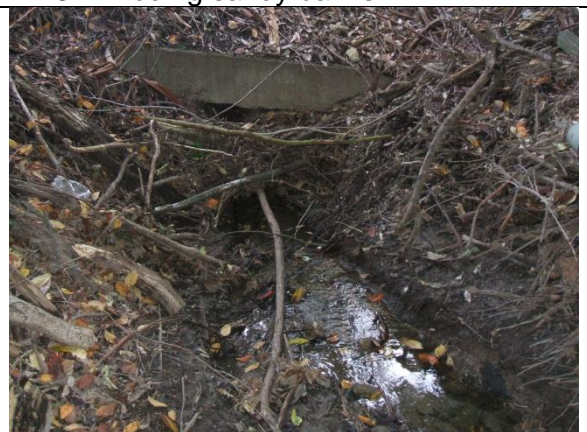
(photo's 8 & 9) has a partially blocked inlet and a scour hole/perched outlet.

8. Partially blocked culvert inlet
