GULLY RESTORATION AND NATIVE PLANTING AREA

Neal Utting
54a Urlich Avenue
Hamilton
Ph: 07 843 4421
Email: edent@ihug.co.nz

April 2005

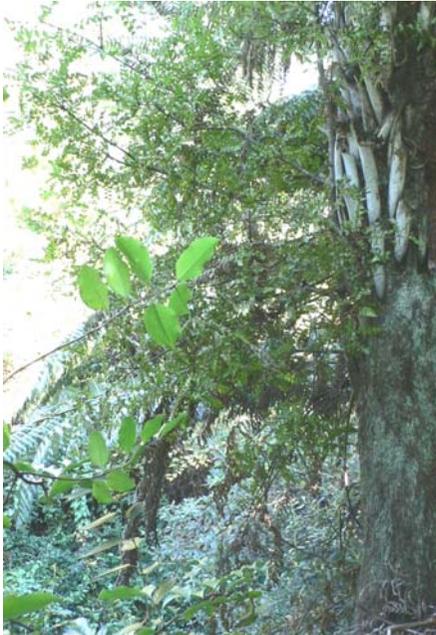
Fig. 9: Tanekaha growing from a ponga

Site ⑪ A ponga, which seems to have grown naturally at the top of the cliff, has a tane-kaha growing from it (Fig. 9, next page). Where this came from is a mystery.

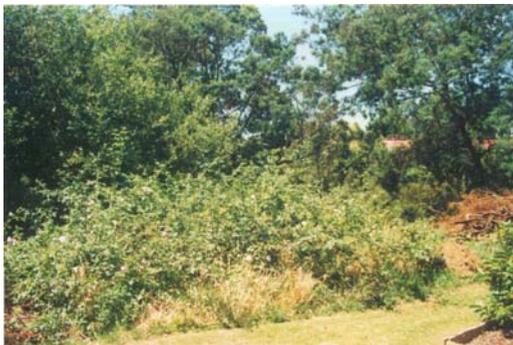
I began work on this property, of almost 2000 m², soon after taking up residence in November 1994. At that time the “paved, lawn, gardens” area on the sketch map (p5) was in lawns and some gardens; the remainder (about 75% of the total, and which generally slopes steeply) was an impenetrable tangle of blackberry, honeysuckle, convolvulus, and other weeds (Fig. 1), with some tree ferns (mainly ponga), some flax, and a couple of cabbage trees.

Fig 1: Initial blackberry, etc. where the vegetable garden is now

The initial method of clearing was to crawl under the blackberry with hedge-clippers, cutting as I went; this resulted in many scratches and prickles. For further clearing I used Grazon spray, which worked quickly and effectively. However, clearing the dead blackberry vines was a further painful procedure.

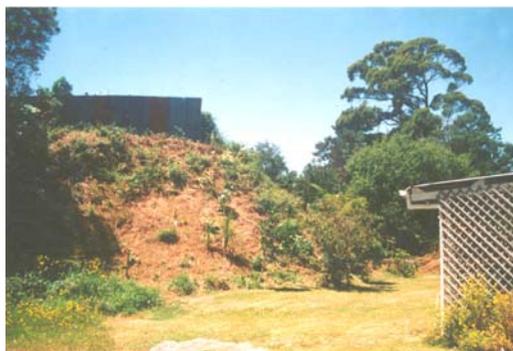
The first part cleared and planted was the area which rises at the north-east, from the edge of the lawn (Fig. 2). Planting initially was largely of poroporo — I had quite a number of seedlings of this — in the hope that these would grow quickly and establish shelter for other plantings. This occurred as planned, and most of the poroporo were removed after two or three years. The planting on this slope was mainly shrubs, as large trees would block the morning sun from the east in winter.

Fig 2: Hill above lawn, cleared (early 1995)

Site ①: The hill above the lawn. This was the first area cleared and planted (see Fig. 2). It seems that, before the house was built (1960s), the right-of-way from Urlich Avenue was formed with a culvert across a side stream, then built up with soil removed from the front of this hill. Plants are now well established (paths and steps on this hill are virtually impassable in places).

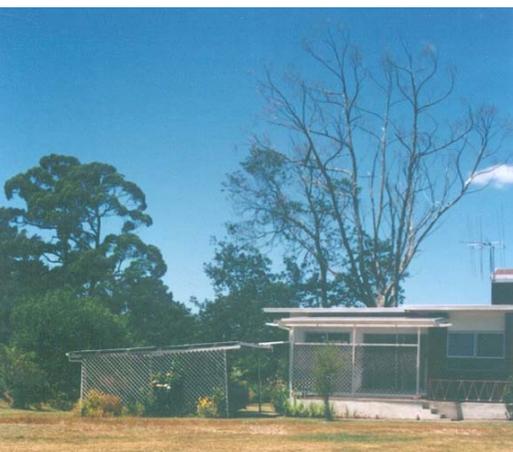
Fig 3: Dead gum tree down gully behind house, before felling

Site ⑩ A large dead gum tree (see Fig. 3) was removed late in 1995. Steps down to this from the left were built to give access, and some steps going further down across the slip area were added later, but before the slip occurred. The pegs and half-rounds at the side of these steps prevented blocks of soil slipping during the slip (see also Site 12 notes); this gave the idea for stabilising the slip using posts and half-rounds.

(Fig.3). I put in steps down to this to allow a tree-feller access (two large wattle trees further down, and a large pussy willow just below the "landing", were later also professionally removed, and the branches of a very large wattle removed in mid-2004).

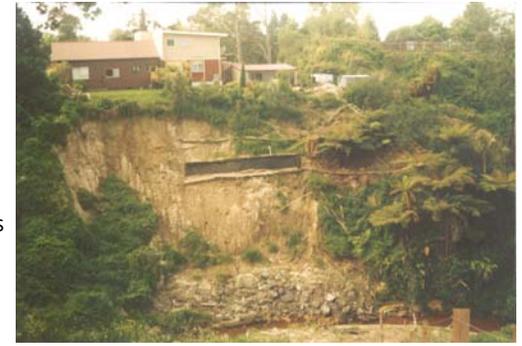
About two weeks later the "Main slip" at the south occurred across my property and my neighbour's. The City Council responded promptly, clearing logs from the bottom and placing a quantity of large boulders at the foot of this slip (these can be seen in Fig. 4). The "Main slip" reached the top in my neighbour's section, but on my section the upper part was held in place (precariously) by pegs used to hold steps which had been put in place. A little later the main part of the "East slip" came down, with a large log moving down about 10 metres with it (see Fig. 5).

Fig 4: The "Main slip" with some stabilizing (early 1999)

Work began immediately on stabilising the slips, with assistance initially from members of South Hamilton Lions Club. The method adopted was to use a hand post-hole borer to dig at about 45° to about 800mm, then an extension was fitted with holes drilled to about 2100mm. Drilling was carried out from temporary platforms of half-rounds across pairs of pipes driven into the bank below the post-hole level. Holes for about 160 posts were drilled in this way; however, later near the stream soft rock was encountered, and a heavy crowbar, and later a spiked weeder, were used to break this up before drilling further (1800mm posts were generally used here). Three half-rounds, with the inner of these buried into the bank, were nailed across each pair of posts (diagrams next page).

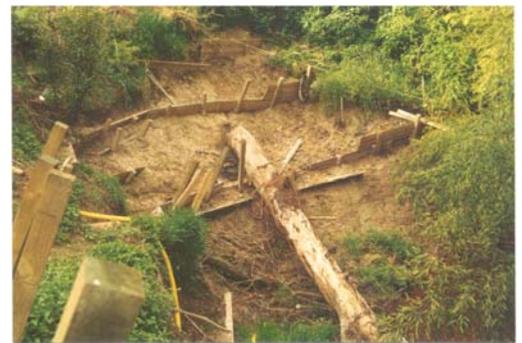
Fig 5: The "East slip" during stabilizing (early 1999)

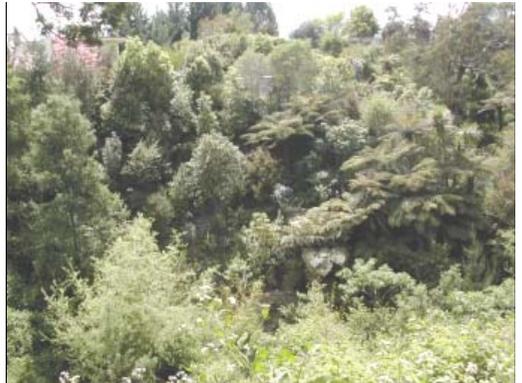
Fig 6: The "Main slip" stabilised and planted (October 2003)

Weed mat was laid across the slip area, below the “landing”, and along part of the stream, secured by pins formed from wire. Trees and shrubs were planted through this. When weed mat is removed, the soil underneath quickly becomes covered with colonising mosses and ferns, (which have also become well established on paths and other banks).

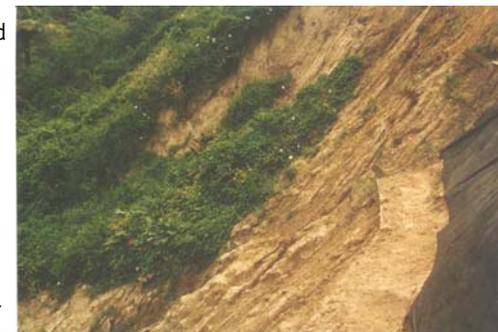
Fig 7: Part of the “Main slip” stabilised (early 1999)

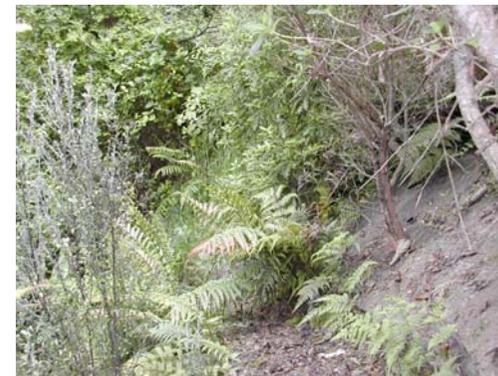
Fig 8: The same part stabilised and planted (October 2003)
